Research
Note
FPL-0240

By
G.E. SHERWOOD
and
W.A. GATZ
Forest Products Laboratory,²
Forest Service
U.S. Department of Agriculture

Performance of Wood in a Do-It-Yourself Solar Collector¹

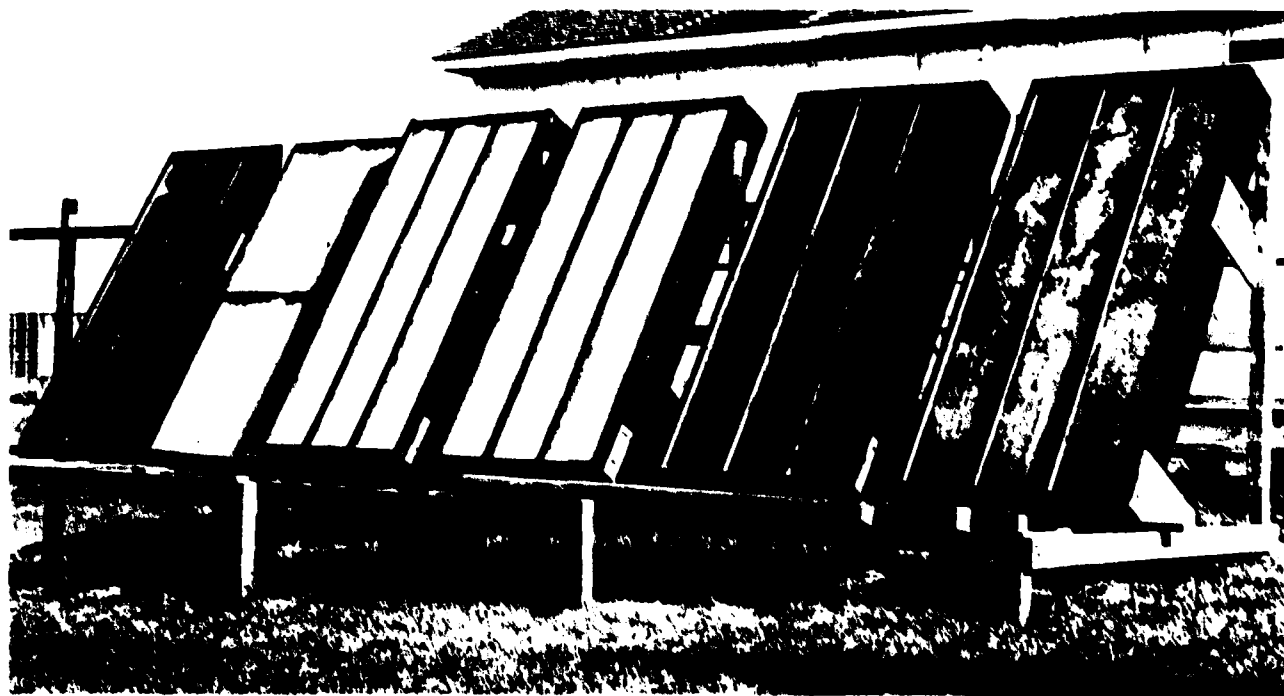
Figure 3 —All six solar collector panels mounted at the exposure site

The mottling in the panel at the far right is the result of the black lacquer peeling off the metal collector plate and settling to the bottom of the panel.

In the second panel from the right, the arrow shows the crack in the glass of Panel 3.

There appeared to be no major difference in the radiant heat collection ability of the two types of paint. The flat black paint used performed well with no peeling, blistering, or other signs of deterioration. The lacquer used did peel from the metal collector (fig. 3), and slightly lower temperatures were observed in the collector after peeling.

produced slightly higher maximum temperatures than did glass. The flat fiberglass used in combination with corrugated plastic performed as well as two sheets of flat glass. A large crack occurred in one of the sheets of glass (fig. 3).
